EXHIBIT G

May 9, 2019

Re: *Susman, et al. v. The Goodyear Tire & Rubber Company*

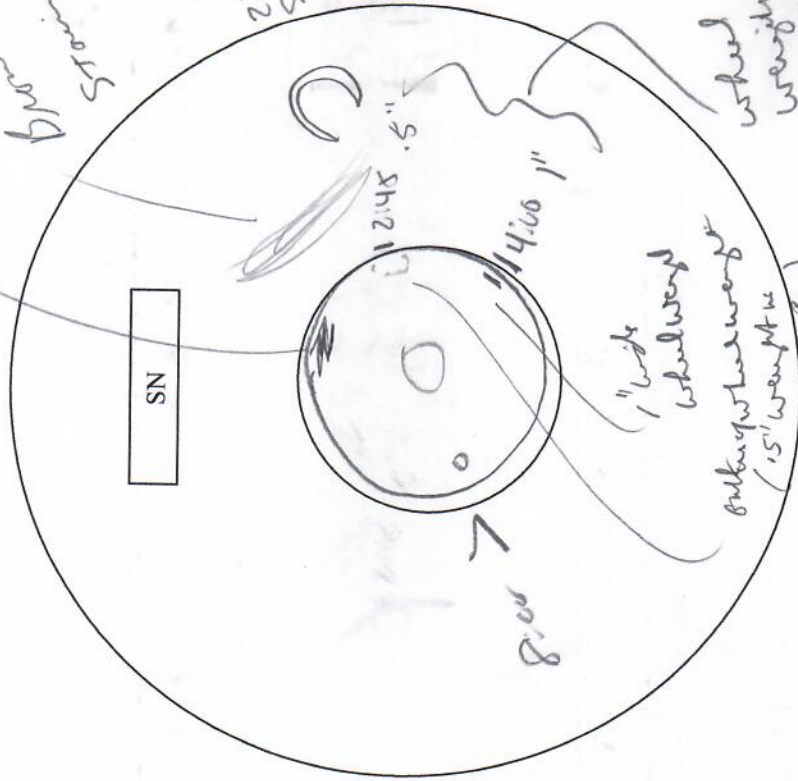
2) Inner Liner Sound.

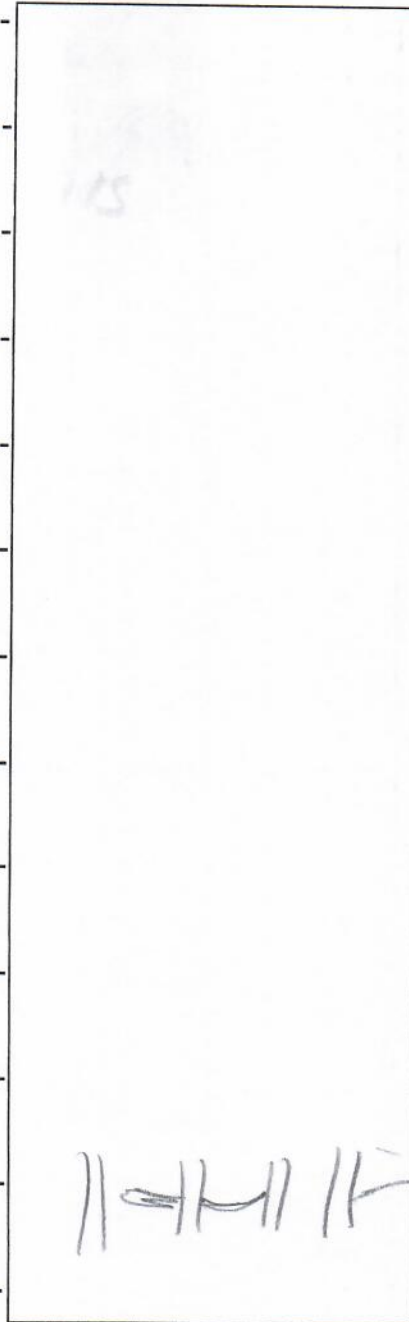
LF COMPANION

11:00 Visible
Cosmetic openings
of leading edge
of tread surface

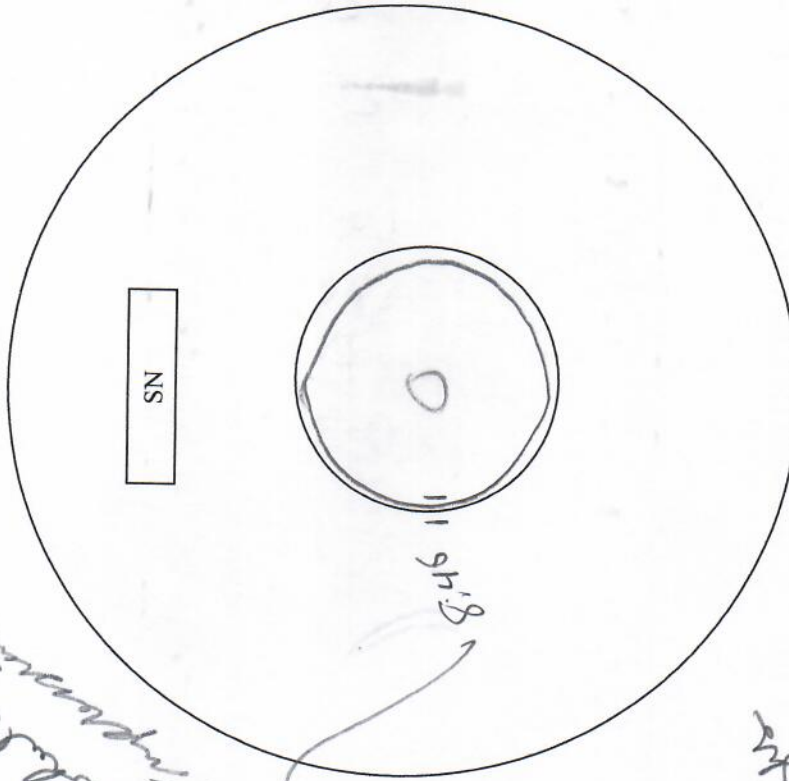
3) SS Sidewall Dirty.

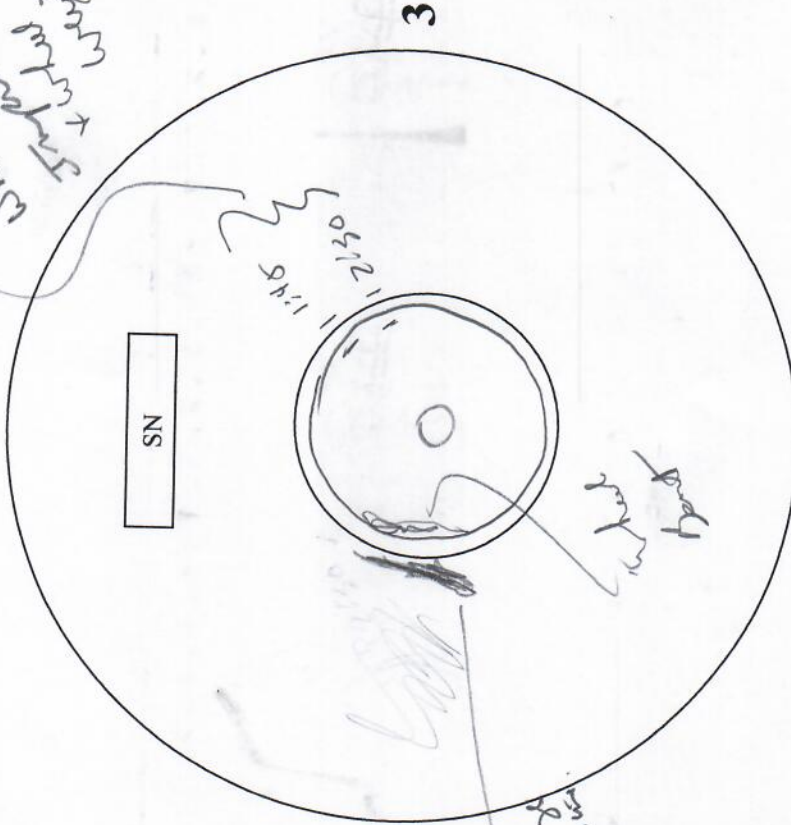
3) SS Sidewall Dotting
